**North American Society for Trenchless Technology (NASTT)
NASTT's 2017 No-Dig Show**

WM-T6-02

**Newport Beach Back Bay Storm Drain Rehabilitation
using PVC Spiral Wound Liners**

Jacqueline Jaques, Sekisui SPR Americas, Los Angeles, CA
Joseph Dominguez, Heitkamp, Inc., Watertown, CT
Frank Durazo, Burtech/Nuline Technologies, Encinitas, CA

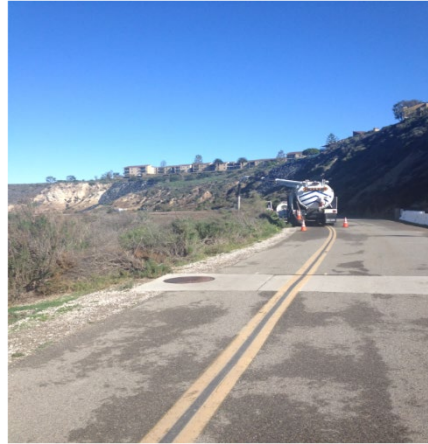
Figure 2. Project Site Conditions

The Back Bay project presented numerous mobilization challenges. Site access was limited due to regulatory restrictions as well as narrow roadways and limited off road parking and staging areas. During the day, the preserve is active with sport enthusiasts, school and scouting groups as well as environmentalists conducting a variety of tests and evaluations. All work in the tidal areas had to be done during day light hours when the park was open to the public so construction site safety was critical to the success of this project (see Figure 2.).

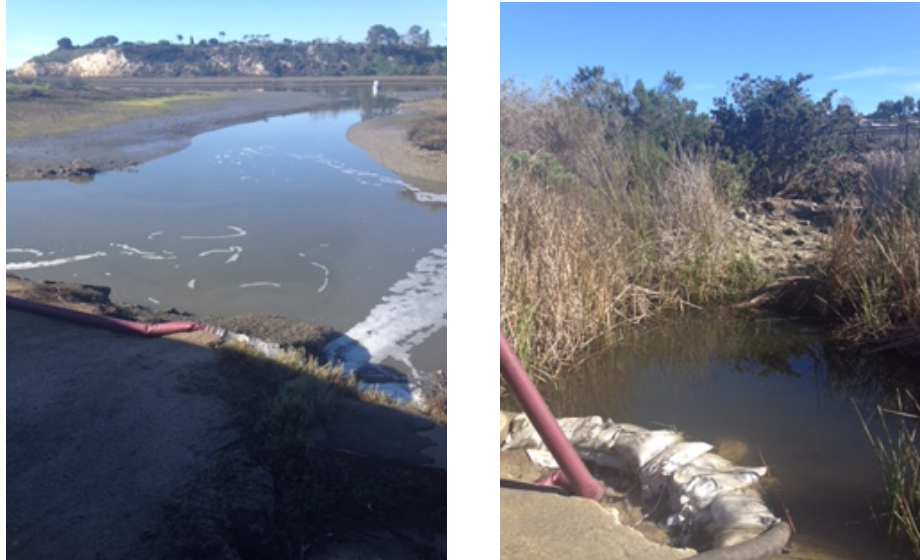
Figure 4 – Tidal Condition

One of the major challenges the contractor faced on this project was the majority of the storm system was under constant tidal flows. However, protecting the environment was also a key concern. From the contractor's perspective, it was important to express their concerns about the use of rehabilitation methods containing styrene due to their potential for site contamination and long term impact on the environment and wildlife. By offering a value engineering proposal to the city, not only was the contractor able to save the City of Newport Beach money, they were also able to execute the scope of work on this extremely difficult project with "zero" environmental impact (see Figure 4).

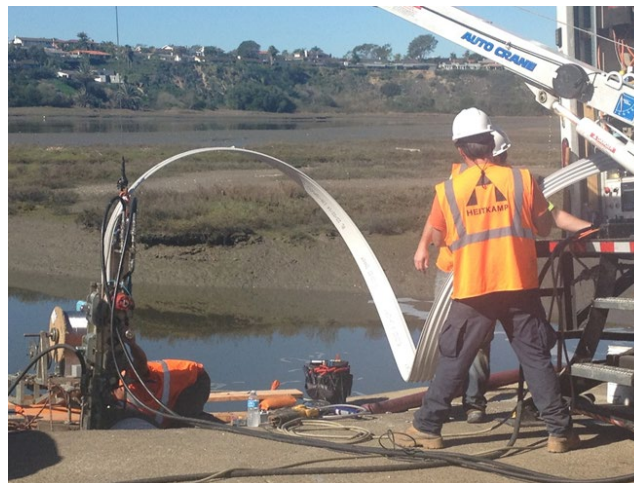
Figure 5 - Project Execution

Due to the constant tidal influences, the contractor found that utilizing the Spiral Wound lining system in the tidal areas gave them greater control within the allowable working time frames (see Figure 5). The remaining culvert segments utilized a combination of spot repairs, CIPP and dig and replace methods. By utilizing Spiral Wound liners, the contractor could work through the tidal changes, improve construction efficiencies and in the end prevent any contaminants from entering the Newport Back Bay (see Figures 6 and 7).

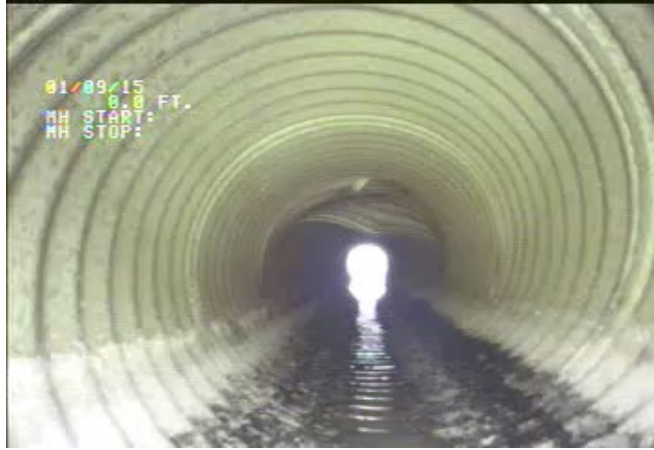
Most of the culvert segments had excessive ovality and deformation with some culverts having up to 20% deflection. Approximately half of the 53 culverts ranging in diameter from 12" to 24" used the Spiral Wound lining process. Further evaluation and repair methods were used on the remaining pipe segments due to hydraulic constraints.

Figure 6. Pre-Rehabilitation – Arizona Crossing - Severe Pipe Deformation

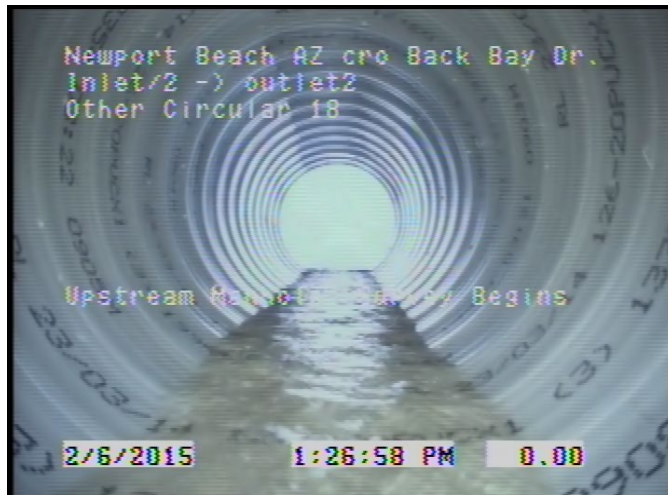
Figure 7. Post Installation Using Spiral Wound Liners
