# ROADSIDE RENEWAL

*in the San Bernardino Mountains*

Rehabilitating storm drains and culverts for transportation departments can be a challenge, particularly when working in difficult site conditions. Nu-Line Technologies, Inc., of Encinitas, CA was recently awarded a project by Caltrans District 8. The project was located near Running Springs, CA in the San Bernardino Mountains. The scope of work included the rehabilitation of 24" and 30" inch CMP storm culverts along the State Highway 330.

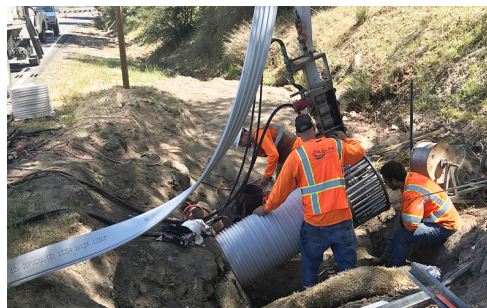
The SPR™EX construction footprint is small and the set up fast and efficient. The installation equipment is highly portable, allowing the contractor to do difficult and remote access set up. Due to the environmental and biological concerns from construction materials and methods, it was imperative that the contractor use the most environmentally friendly construction materials. The project required the Contractor to submit a Water Pollution Control plan as part of their pre-construction submittal package. As Spiral Wound liners are mechanically installed, there was no concern about potential styrene contamination as would be the case if the contractor used a resin impregnated liner.

SPR™EX is a tight fit lining solution for 6" – 42" diameter gravity pipelines. The liners are initially installed at a fixed diameter, smaller than the host pipe. Typically, winding occurs from upstream to downstream, however reverse set ups can be done. The liner is formed via a static winding machine that joins subsequent strips of profile and creates a structural liner within the host pipe. Once the liner reaches the termination structure, the liner is torsionally restrained, then expanded by severing the secondary or "sacrificial" lock. This action allows the profile to expand creating a tight fit liner which requires no annular space grouting. Furthermore, the entire installation process can be done in live flow conditions typically without the need for by-passing.

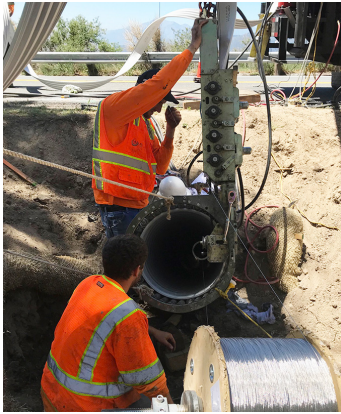
Site access on this project was particularly difficult. Route 330 is a two lane highway located in the San Bernardino Mountains. Traffic control would need to be carefully managed with this passageway being popular with tourists. The project site required a minimal presence as to keep the flow of cars moving and not to create safety/travel interference. Access to the

culverts was even more challenging. The inlets were typically located off the shoulder in wooded areas with the outlets located down steep inclines in dense brush. The SPR™EX installation equipment was typically set up at the upstream inlet. Crews were also located at the downstream outlet where they were able to hand carry

equipment necessary to terminate the liner and to install end seals. Due to slope and host pipe deformation, the contractor had to make intermittent adjustments to the installation equipment to control the lining process.
