CASE STUDY

SPR™ RO

1182 Budapest, Halomi Street, Hungary
Project Name: Halomi Street Sewer Rehabilitation
184 m DN1200

Halomi Street Sewer Rehabilitation Project:

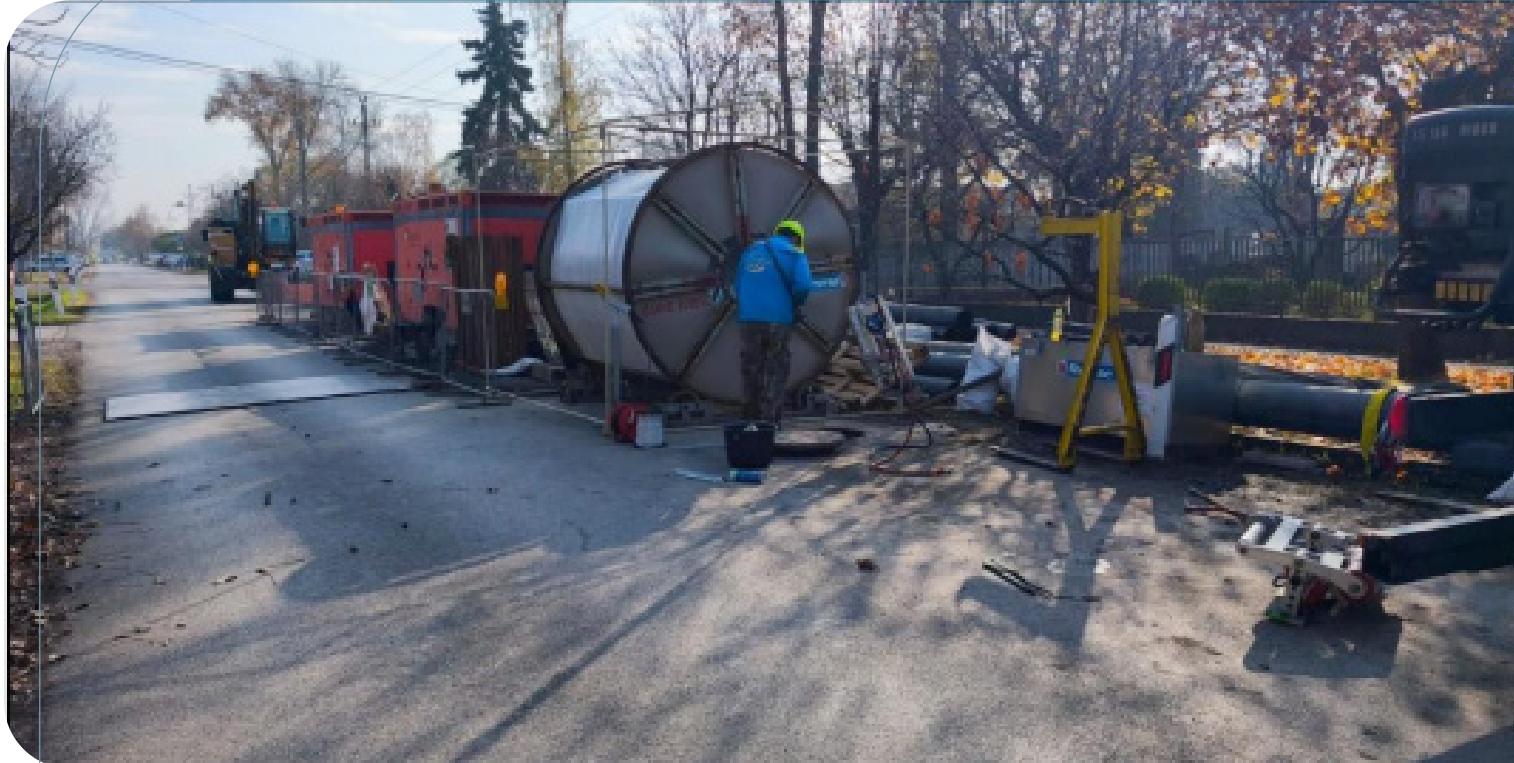
The Halomi Street Sewer Rehabilitation project in Budapest (Client: Fővárosi Csatornázási Művek Zrt.; Distributor: Sekisui Chemical GMBH; Partner: Agriapipe Kft.) required a fast, trenchless solution due to severe internal corrosion caused by hydrogen-sulfide exposure and the pipe's location beneath a heavily trafficked roadway. The RIB Loc / Rota-LOC trenchless technology was selected for its proven structural reliability, compatibility with site conditions, and ability to minimize surface disruption. Installed between November 3–18, 2025, the method fully met all technical, structural, and environmental requirements.

The rehabilitation was completed quickly, without traffic impact, and delivered a high-quality, fully compliant restoration of the pipeline. Aggressive wastewater from the upstream regional sewer network had caused significant biochemical and chemical corrosion along the interior surface of the pipeline. Prolonged exposure to hydrogen-sulfide-induced acidification and anaerobic by-products led to visible deterioration of the pipe wall, confirming the need for comprehensive rehabilitation.

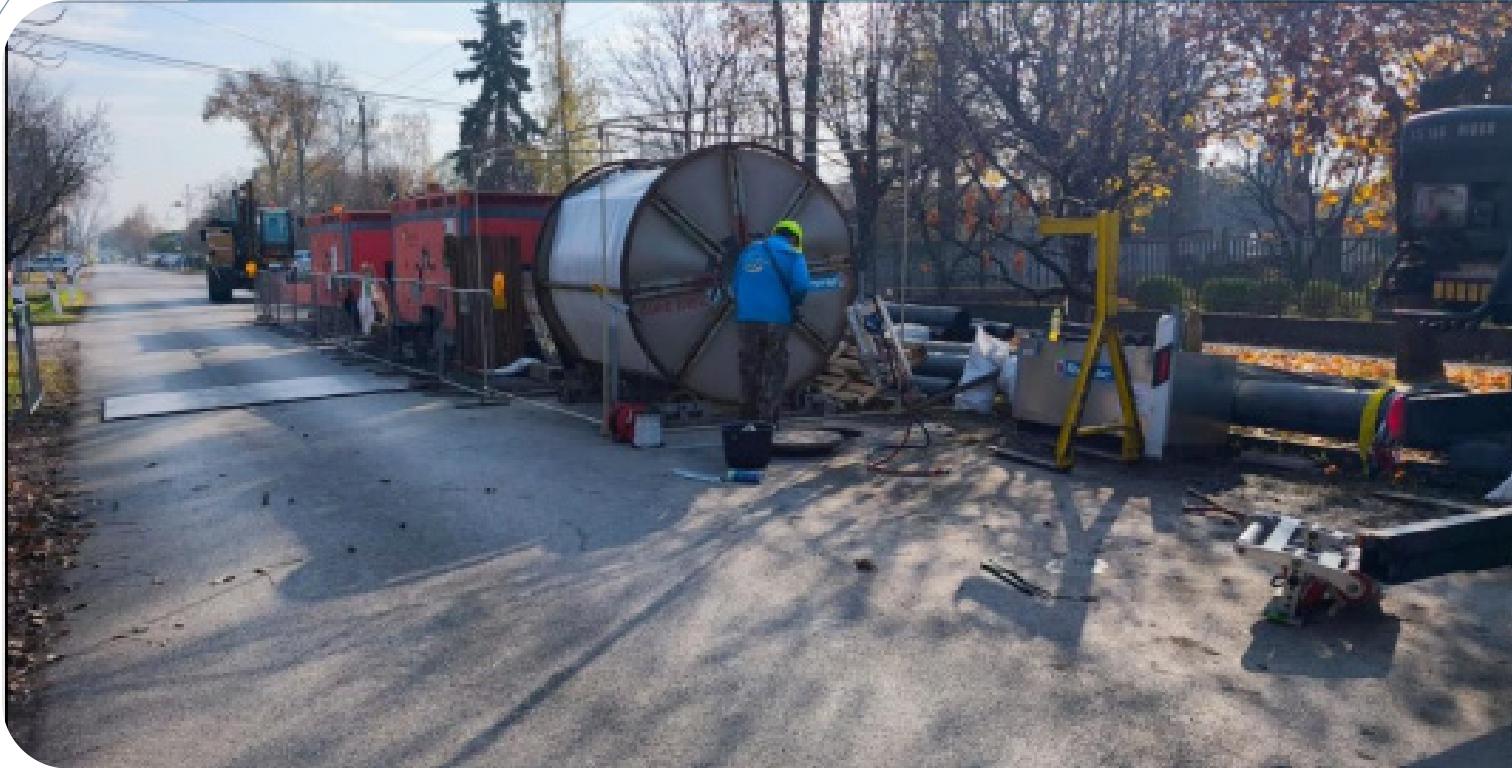
The Halomi Street Sewer Rehabilitation project in Budapest (*Client: Fővárosi Csatornázási Művek Zrt.; Distributor: Sekisui Chemical GMBH; Partner: Agriapipe Kft.*) required a fast, trenchless solution due to severe internal corrosion caused by hydrogen-sulfide exposure and the pipe's location beneath a heavily trafficked roadway. The RIB Loc / Rota-LOC trenchless technology was selected for its proven structural reliability, compatibility with site conditions, and ability to minimize surface disruption. Installed between November 3–18, 2025, the method fully met all technical, structural, and environmental requirements. The rehabilitation was completed quickly, without traffic impact, and delivered a high-quality, fully compliant restoration of the pipeline. Aggressive wastewater from the upstream regional sewer network had caused significant biochemical and chemical corrosion along the interior surface of the pipeline. Prolonged exposure to hydrogen-sulfide-induced acidification and anaerobic by-products led to visible deterioration of the pipe wall, confirming the need for comprehensive rehabilitation.

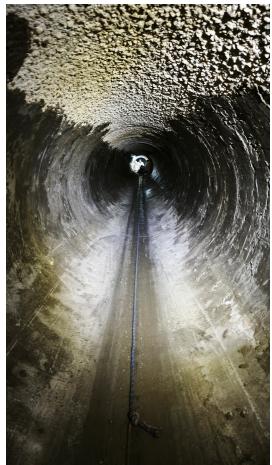
Before Lining

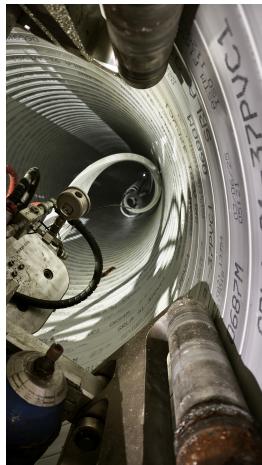
During Lining

The Rota-LOC technology met all project-specific requirements and technical specifications, fully complying with the structural, operational, and environmental criteria established for the rehabilitation works. Owing to its proven reliability, compatibility with the site conditions, and its ability to ensure rapid, trenchless execution without compromising pipeline integrity or traffic flow, this method was ultimately selected as the most suitable solution for the project. The rehabilitation carried out using the Rotaloc technology delivered fully satisfactory results. The installation was executed in complete accordance with the relevant technical specifications and regulatory requirements, and the implementation process was completed within a notably short timeframe. The method ensured a high-quality outcome while minimizing disruption, thereby fully meeting the expectations set for the project.
