LARGEST SPR™ PROJECT

Peachtree Trunk Sewer Stabilization Project

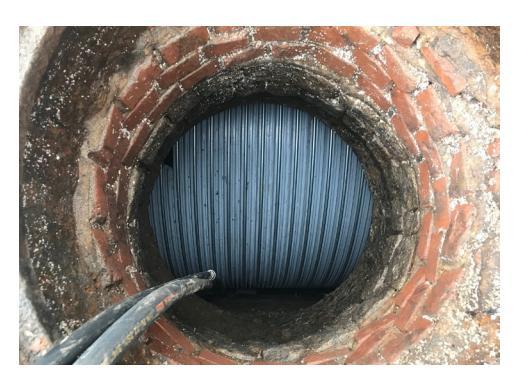
The sewer began to show its age with cracks, failures and concrete degradation that subsequently impacted the surrounding community and environment.

In response, the City commissioned an Atlanta based contractor, Ruby-Collins, to repair the most concerning sections of pipe immediately following the flood. In addition to the repairs, planning began for a fully structural rehabilitation to address the long term needs of the entire pipeline. This meant designing a solution for over 10,500 lf of the 90-in. arched sewer. 10,500 FT Project Length **82** Liner Diameter 125 YRS Age of Pipe

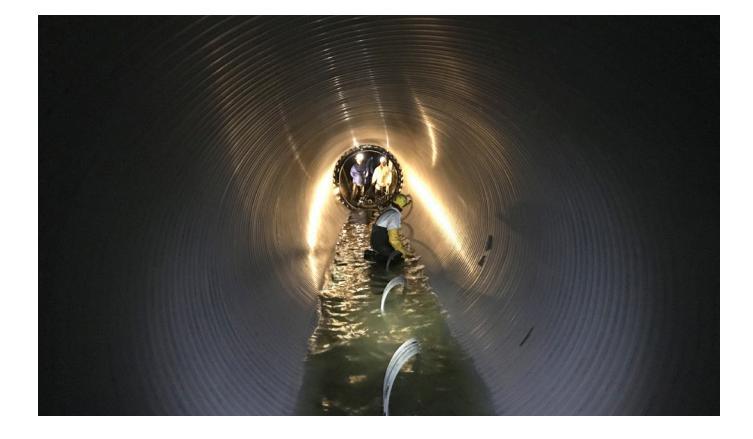
Spiral Wound is a PVC pipe lining method designed to restore sewers, storm drains and culverts from 6 in to more than 200 in. The above-ground footprint, including internal bypassing, provides minimal disturbance; an important benefit for construction within the busy Atlanta suburbs. Spiral Wound also provided the capability to line the bends within the pipeline.

The steel-reinforced PVC liner was constructed using the SPR winding machine. A small crew fed a continuous strip of PVC from a spool above ground to the winding machine below. The strip would then lock and form the liner; a process performed entirely without the use of chemicals.

Once a segment of pipe was lined, the completed section was prepared for grouting. Internal braces were set up within the liner to provide support for installing the grout. The grout injection occurred through a series of internal ports created in the liner's wall. This continuous process of lining and subsequent grouting continued for the entire length of the pipeline.
