# SPIRAL WOUND PIPE REHABILITATION

**6" - 200+"** TRENCHLESS PIPE LINING SOLUTIONS

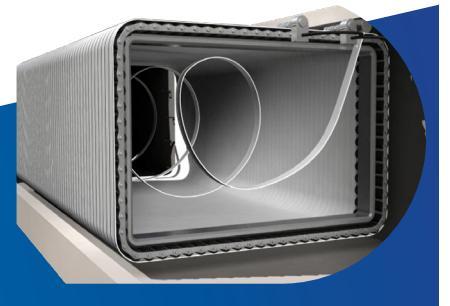
For installations, a continuous strip of PVC is fed from a spool above ground into the winding machine. From there, the machine continuously winds the profile to construct the PVC liner within the host pipe. We offer 3 different winding methods based upon the host pipe.

SPR<sup>™</sup> renews large diameter, round and non-round shaped pipelines. The PVC is wound by a traversing machine that forms the liner while traveling the pipe segment. The liner is constructed leaving a gap between the PVC and pipe wall. This annular space is subsequently grouted.

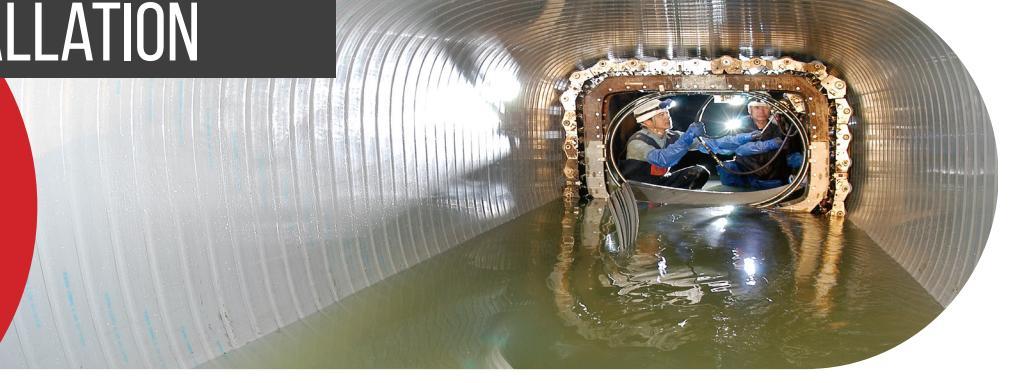
#### **STATIC & TRAVERSE WINDING MACHINES**

SPR™EX is a stationary installation process. The equipment pushes the wound PVC liner from access chamber to access chamber.

In contrast, SPR™TF and SPR™ traverse the pipeline while winding and pulling the liner along with the machine.

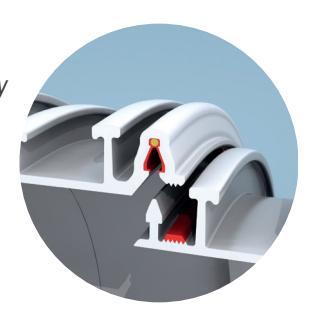
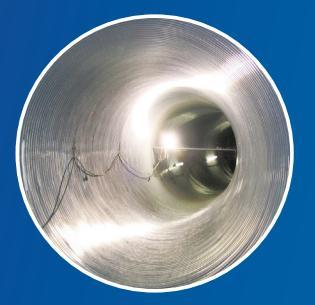
The liner material is a pipe grade PVC with a ribbed profile design, which is for added strength. The profile features a male and female lock along the edge of the material. These are interlocked as successive wraps of the strip are wound by the machine.

Optional Steel Reinforcement

Male Lock

Female Lock

- MECHANICAL LOCK WITH GASKETING MATERIAL
- IMPERVIOUS TO I/I & ROOT INTRUSION
- .009 MANNING'S N VALUE

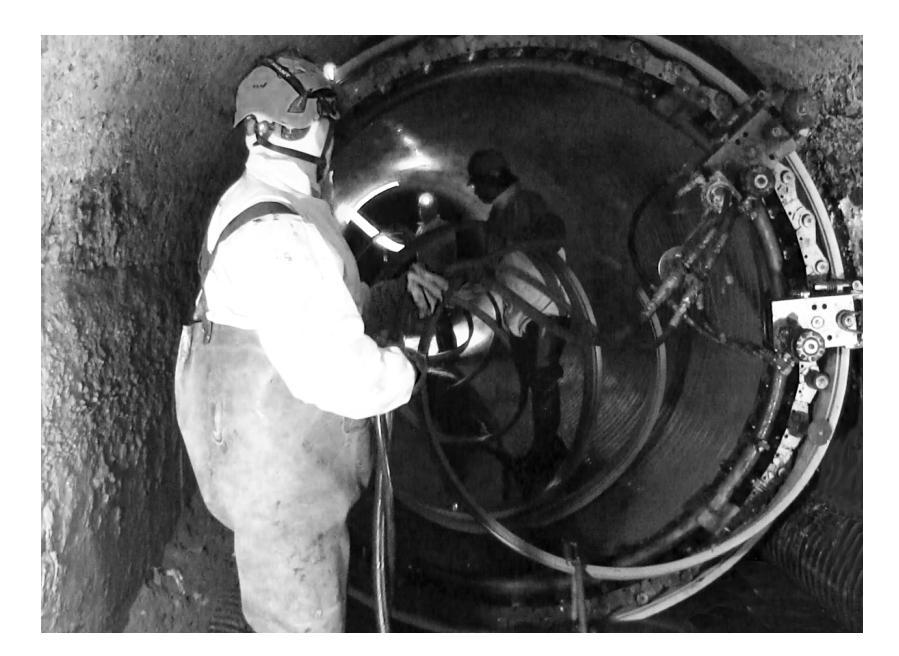
The SPR<sup>™</sup> design called for installation of an 82" PVC liner inside the 90" arch sewer. The annular space was to be filled with lightweight grout to serve as load-transfer for the PVC liner.

The Peachtree Creek Trunk Stabilization project began in October 2018. The rehabilitation of more than 10,500 LF of 90in. arched sewer finished just 10 months later in August 2019; **roughly four months ahead of schedule.**
