CASE STUDY

SPR™

KETY, POLAND

DN1000/1720 (39/68 in), 420 M (1378 ft)

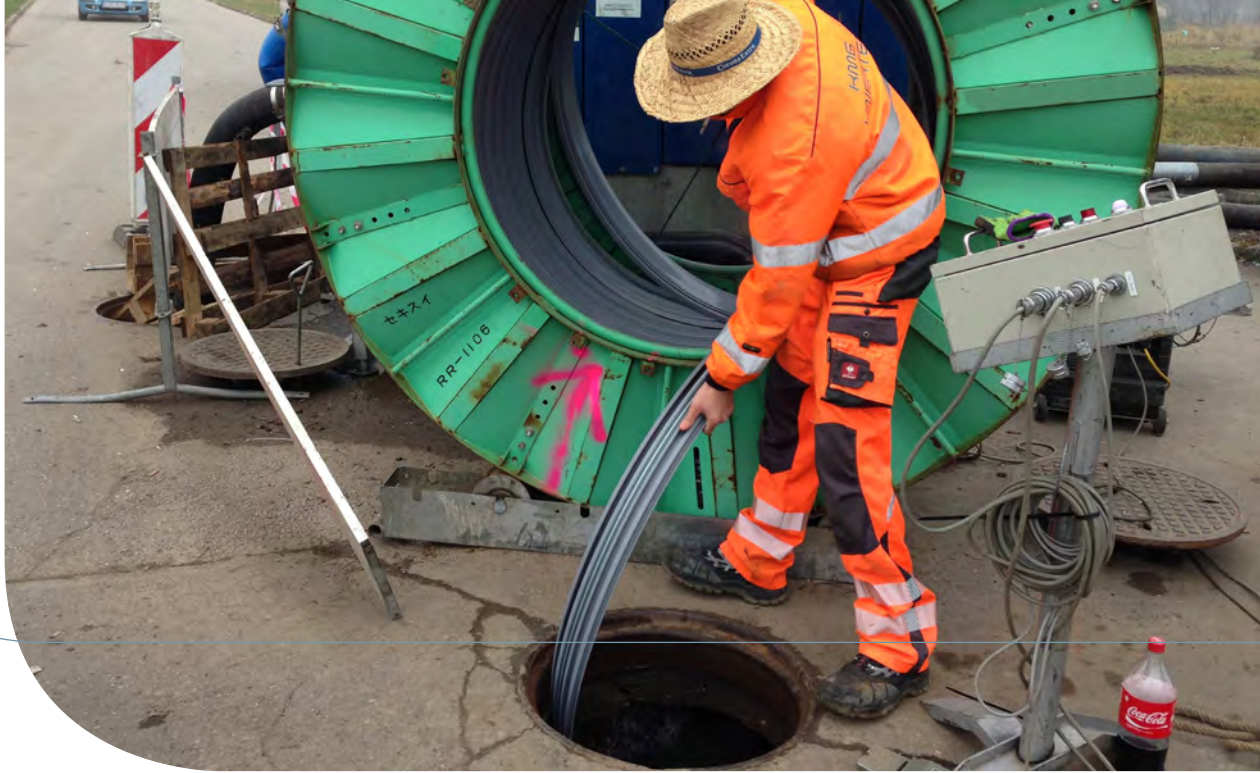
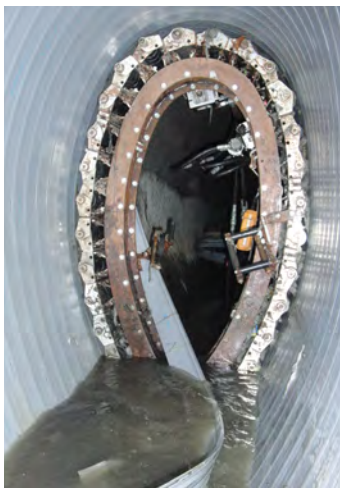
Sewer rehabilitation with the SPR™ spiral-wound pipe technology is no problem under live flow conditions.

With the SPR™ Spiral-Wound pipe method an endless PVC profile strip was wound into a pipe inside the sewer; till the required diameter was reached. A normal inspection manhole was sufficient to bring the winding machine and the PVC profile strip into the sewer. The rehabilitation equipment above ground, which includes the drums with
